INSTALLATION RESTORATION PROGRAM
PHASE II--CONFIRMATION/QUANTIFICATION

STAGE 1

Final Report

AIR FORCE PLANT 6, COBB COUNTY, GA.

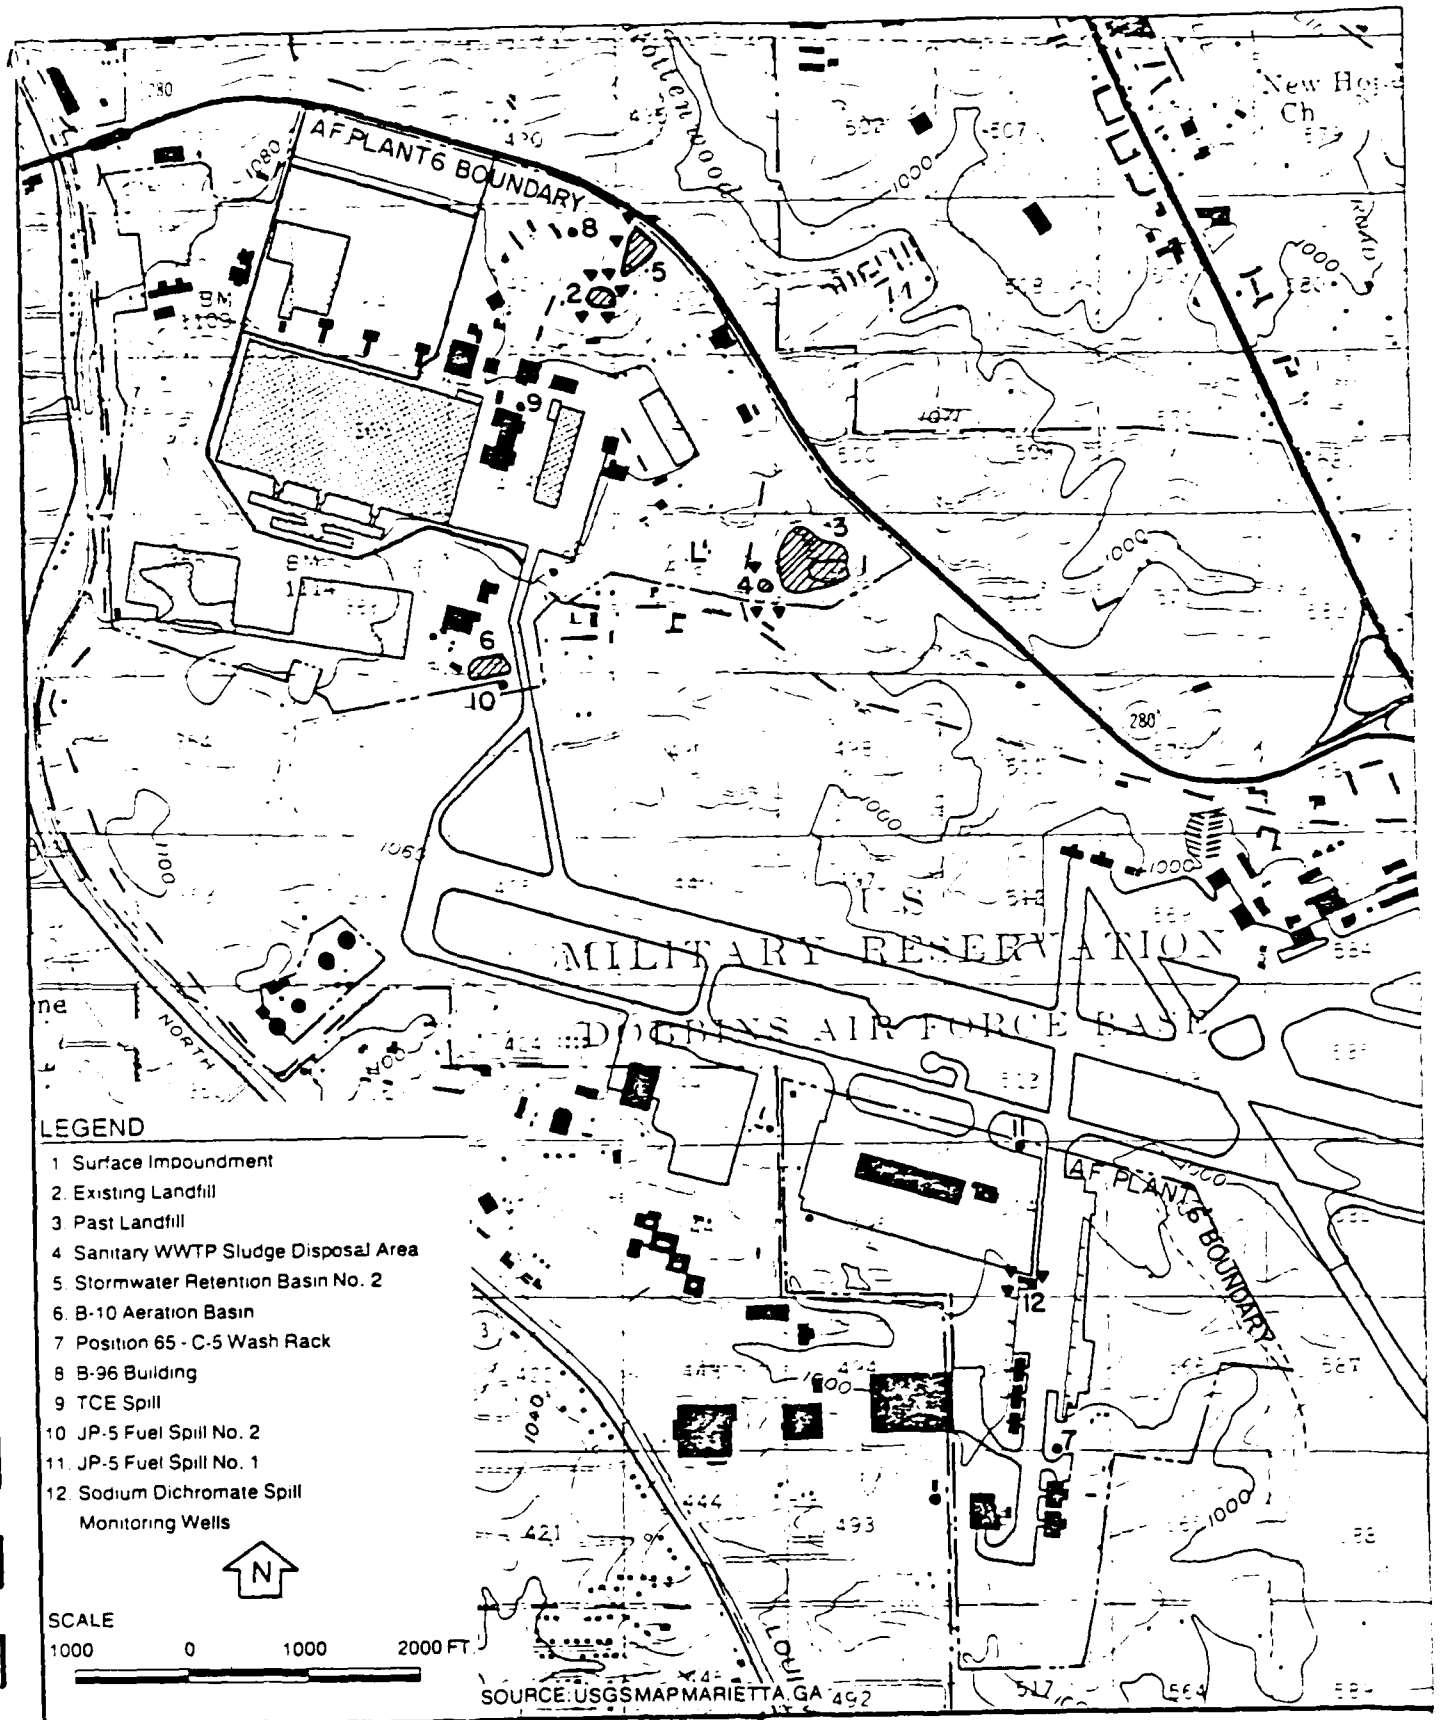
The Chester Engineers			SHEET NO.	LOCKHEED-GEORGIA COMPANY AIR FORCE PLANT 6 INSTALLATION RESTORATION PROGRAM TENATIVE WELL LOCATIONS
DWN.BY:	SCALE:	DATE	DWG. NO.	
CHK'D.BY:	APPR.BY:		FIGURE 1

1. Industrial Waste Sludge Disposal Basin
2. Existing Landfill
3. Oil Landfill
4. Sanitary WWTP Sludge Disposal Area
5. Stormwater Retention Basin No. 2
6. B-10 Aeration Basin
7. Position 65 - C-5 Wash Rack Ponds
8. B-96 Slosh Test Building
9. Trichloroethylene Spill
10. JP-5 Fuel Spill No. 2
11. JP-5 Fuel Spill No. 1
12. Sodium Dichromate Spill

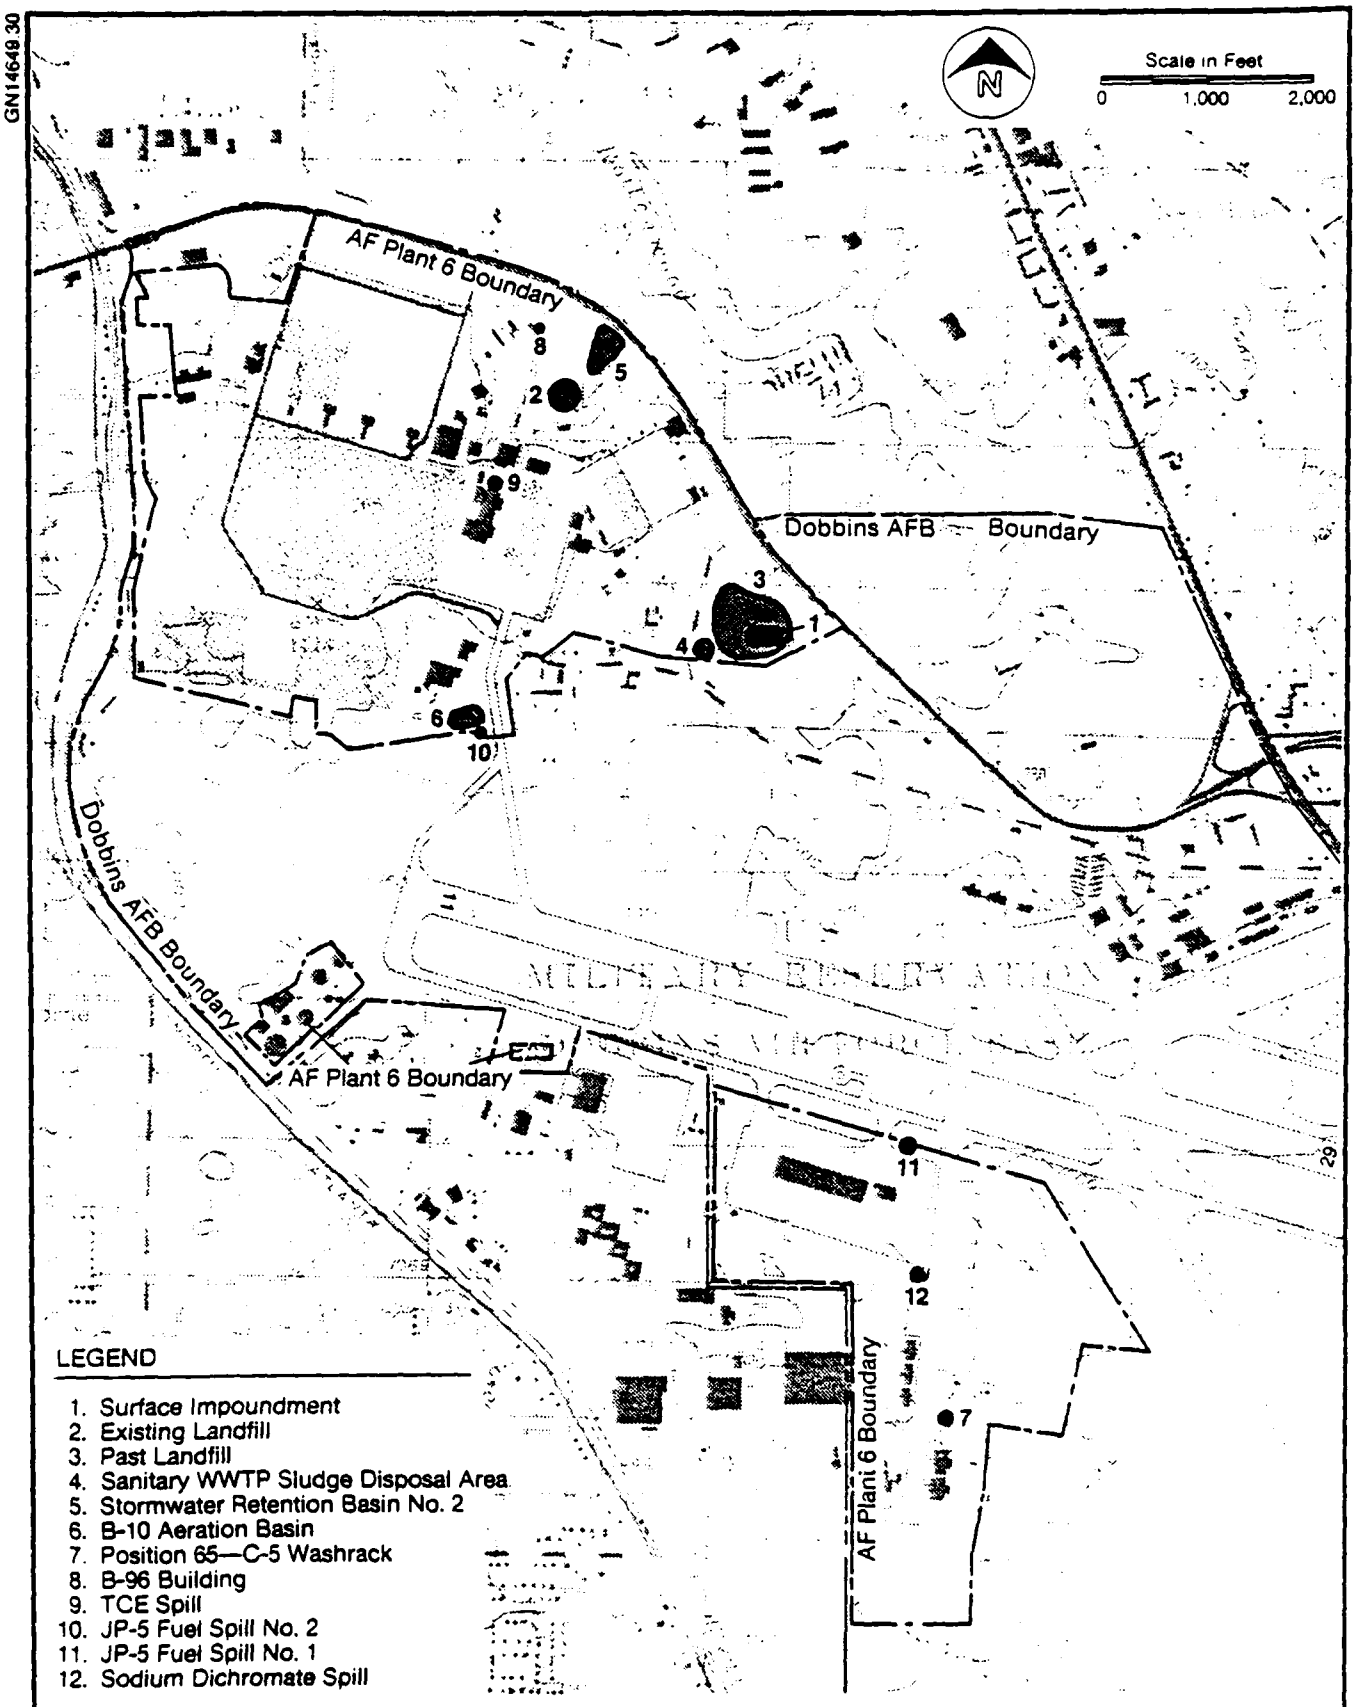
FIGURE 1.
Location Map of Identified Disposal and Spill Sites at AF Plant 6.

3. Interviews with installation employees resulted in the identification of 12 past disposal or spill sites at AF Plant 6 and the approximate dates that these sites were active (see Figure 1 for site locations).

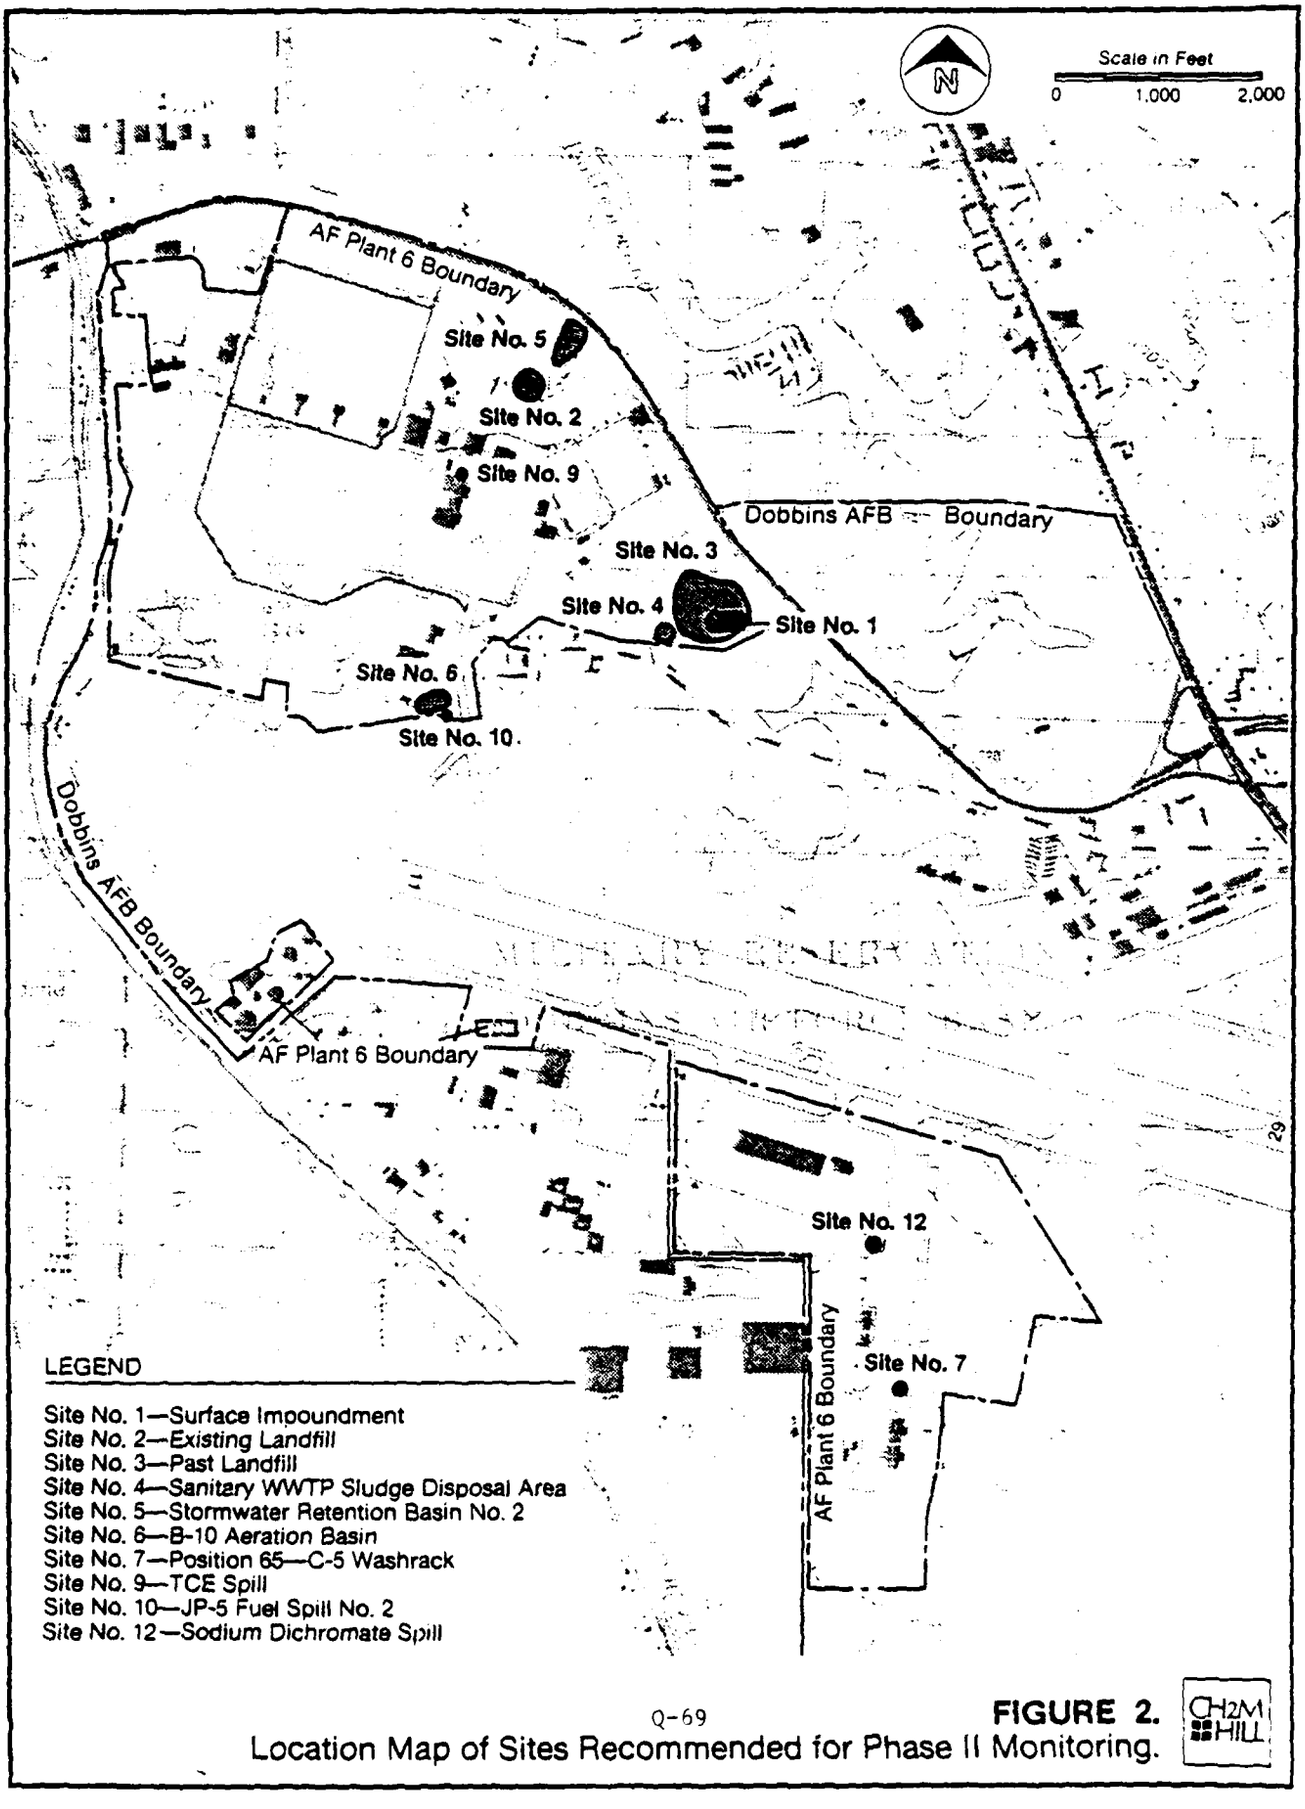
FIGURE 2.
Location Map of Sites Recommended for Phase II Monitoring.

covered by these recommendations. Figure 2 shows the locations of the sites being recommended for Phase II monitoring.

a. Discontinuing the use of the two ponds at Site No. 7, Position 65--the C-5 Washrack. The contaminated water should be pumped to the IWTP for treatment and the ponds should be properly closed. The piping system should be reworked to pump washwater from the washrack directly to the IWTP.

b. Pressure testing all major belowground (BG) tanks.

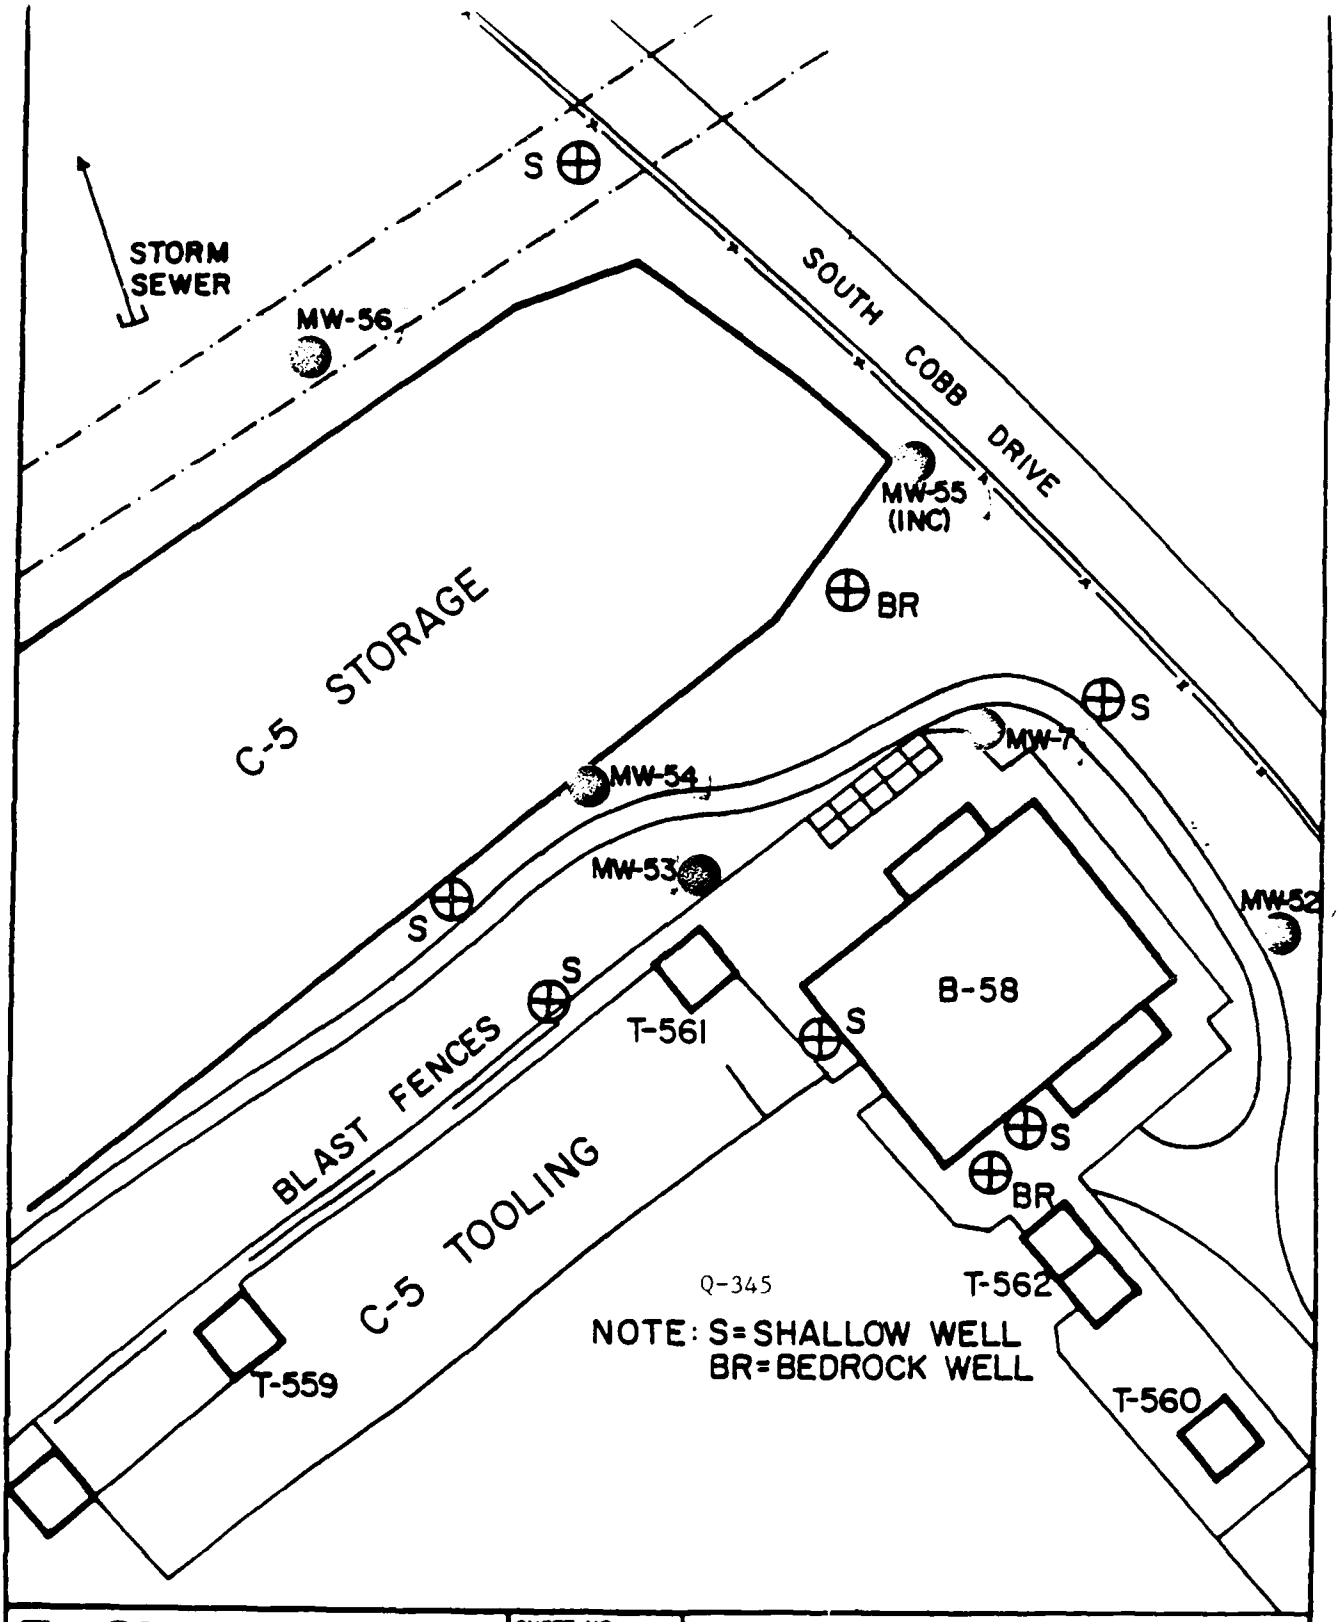
The Chester Engineers			SHEET NO.	LOCKHEED-GEORGIA COMPANY AIR FORCE PLANT 6
DWN.BY:	SCALE:	DATE	DWG. NO.	RECOMMENDED ADDITIONAL MONITORING WELLS
CHK'D.BY:	APPR.BY:		FIGURE III-6

Groundwater flows radially away from the B-58 facility. Contaminated groundwater potentially is carried off Air Force Plant 6 property in a northeasterly direction under South Cobb Drive. One source of contamination is the historic accumulation of minor spills from solvent drum handling procedures. The possibility of active leakage from within B-58 requires further investigation. Additional

6. There may be two sources of contamination. There have almost certainly been historic leaks and spills from the solvent drum handling operations. The possibility of an active leakage source from within the B-58 building requires further investigation.

8. Additional investigations will be required to further define the causes and extent of the contamination. Off-site property access will likely be necessary.

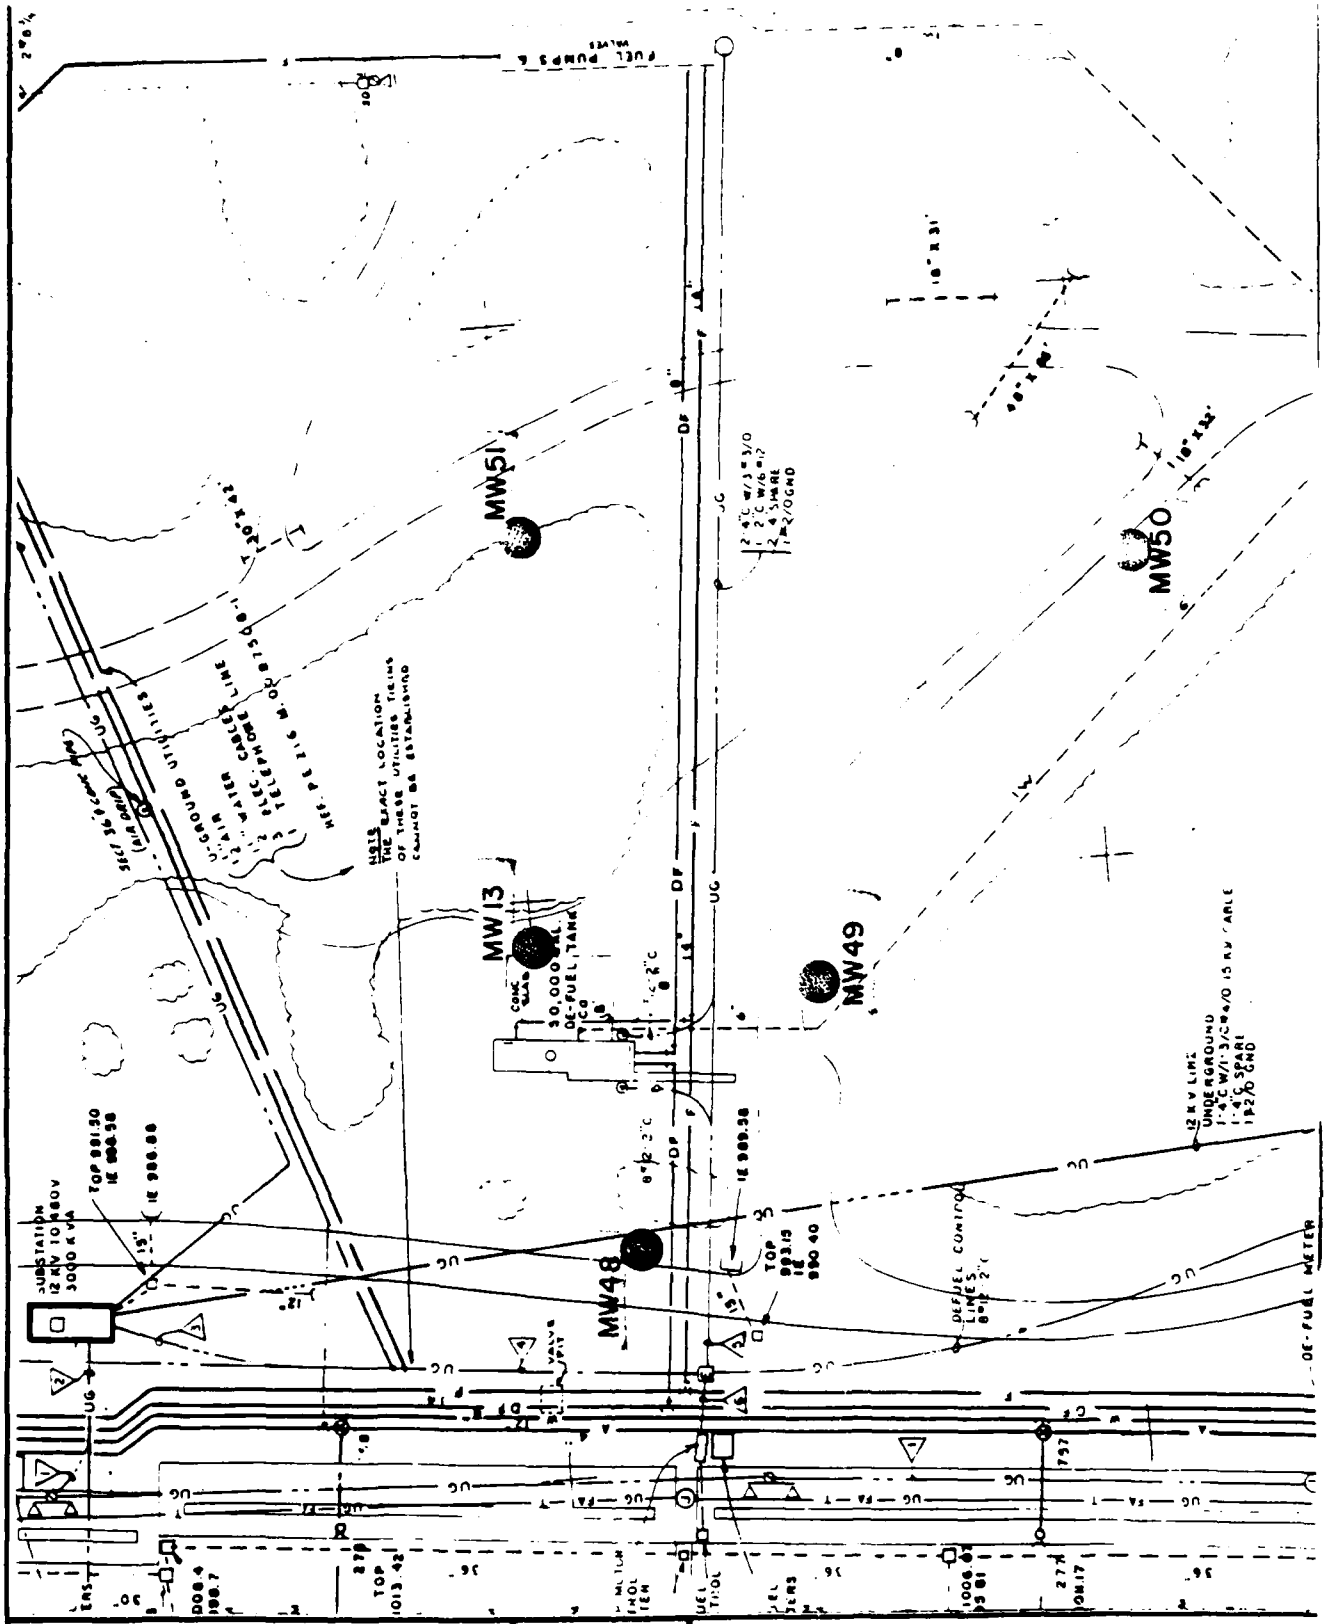
TheChesterEngineers			SHEET NO.	LOCKHEED-GEORGIA COMPANY AIR FORCE PLANT 6
DWN.BY:	SCALE:	DATE	DWG. NO.	POSITION 58 DEFUELING TANK MONITORING WELL LOCATIONS
CHK'D.BY:	APPR.BY:		FIGURE V-1

The underground jet fuel storage tank at Flight Line Position 58 is a major element in the fueling-defueling operations which occur along the Flight Line. The present investigation was triggered by Chester's observation of fuel in MW-13 adjacent to the tank. Fuel had not been previously observed in this well. Four additional monitoring wells were installed to further define the nature and extent of the problem. The major findings are summarized as follows:

1. There is significant active leakage from the tank or immediately adjacent underground fuel lines. The amount of fuel in the groundwater at MW-13 appeared to increase during the course of Chester's study. There was 18± inches of floating fuel in MW-13 at the time of Chester's last inspection on September 11, 1984.

3. The upgradient well (MW-48) along the patrol road has no visible fuel or chemical odor but exhibits significant concentrations of fuel related parameters. The conclusion is that there are/have been indeterminate fuel leaks or spillages in the fuel handling system in the ramp area.

6. The underground tank should be pressure tested to determine if it is leaking. Excavation to determine the nature of the leakage may be required.

7. Immediate groundwater recovery measures should be implemented at MW-13 at least on a test basis to determine the amount of fuel which may be recoverable. Groundwater pumping could control the situation if the source cannot be firmly identified or repairs affected immediately.

8. The contamination discovered in MW-48 will represent a longer term groundwater management problem. Additional monitoring wells should be drilled along the patrol road to determine the lateral extent of contamination. The placement of wells on the ramp area is not recommended at this time pending further consideration of the situation.

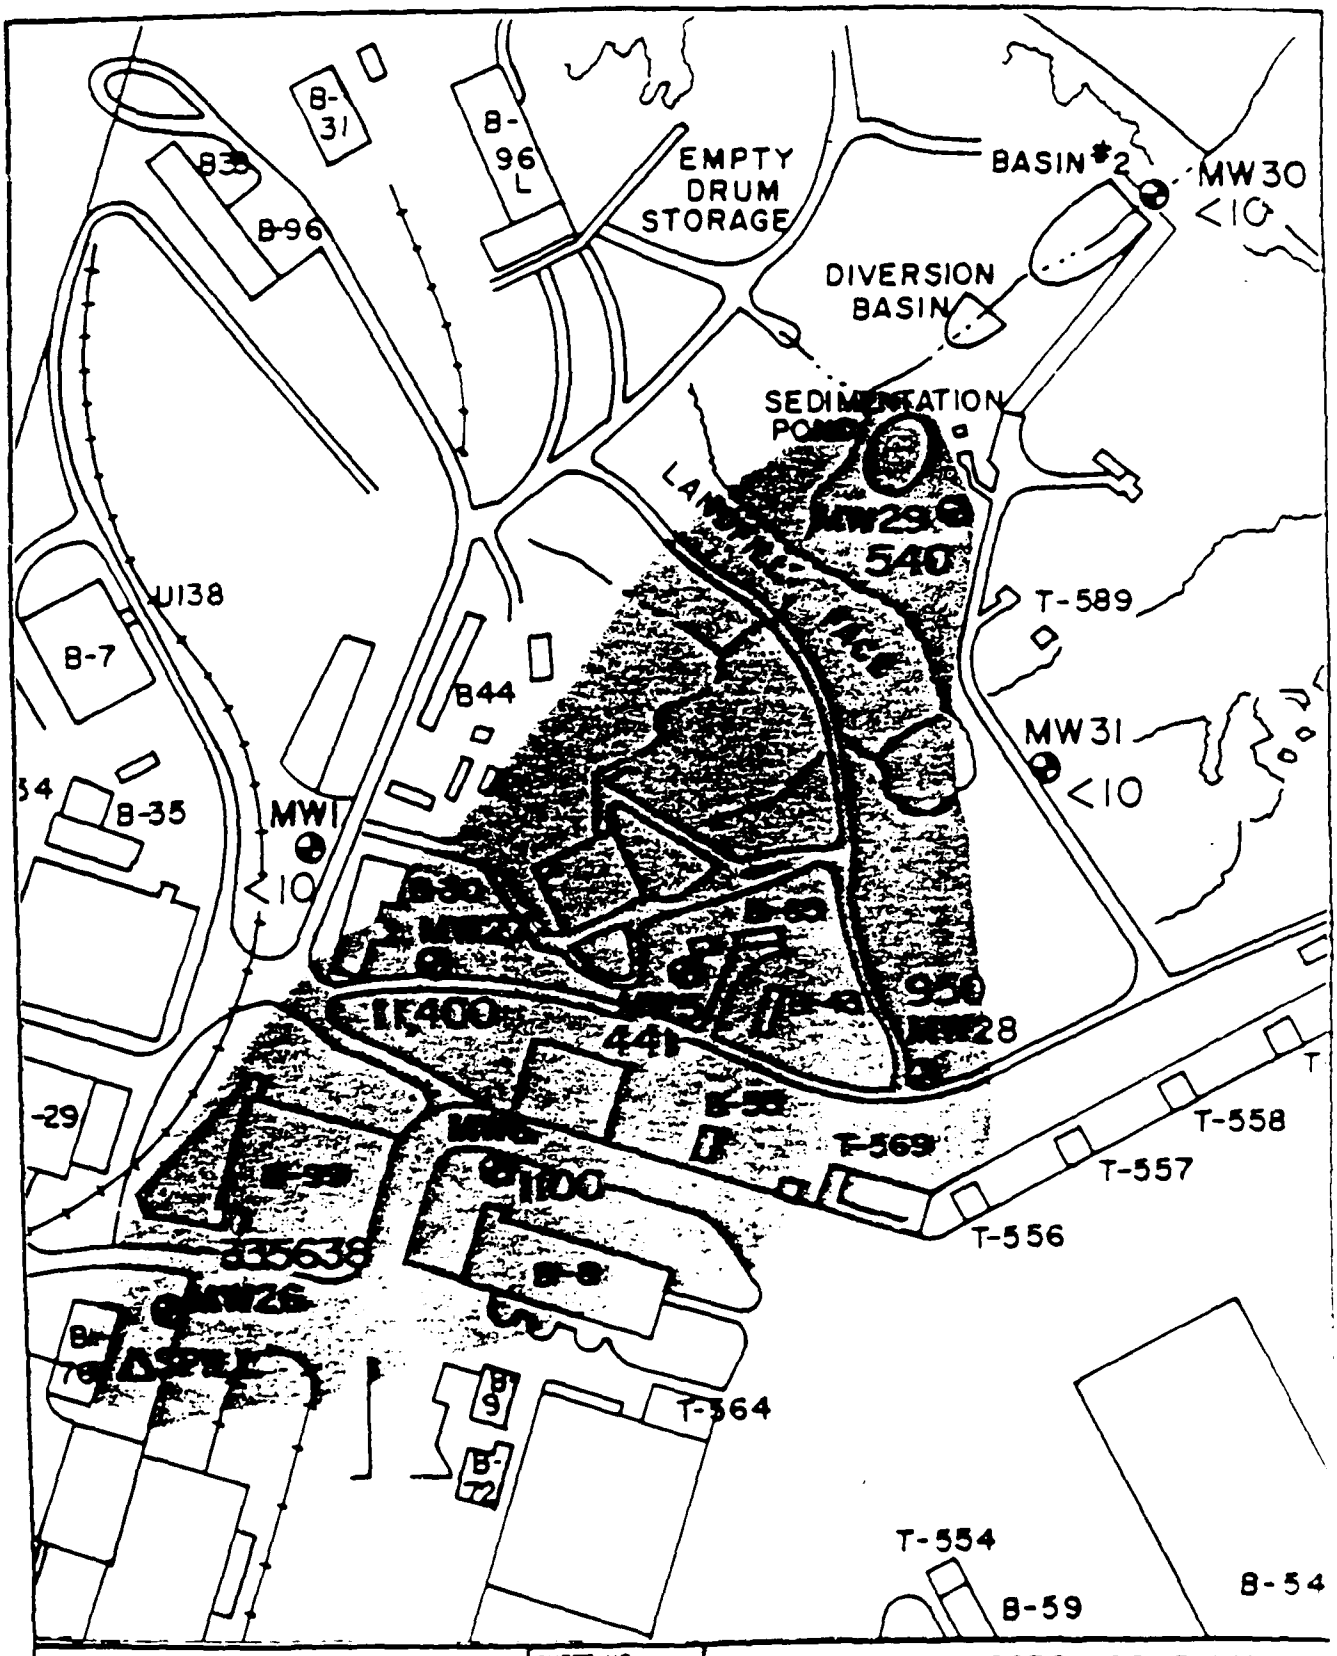
TheChesterEngineers			SHEET NO.	LOCKHEED-GEORGIA COMPANY AIR FORCE PLANT 6 TCE SPILL AREA TRICHLOROETHYLENE ug/L
DWN.BY:	SCALE:	DATE	DWG. NO.	
CHK'D.BY:	APPR.BY:		FIGURE IV-9

5/11/84 BEFORE BAILING	5/14/84 AFTER BAILING
Log 84-	3152	3430
Benzene, ug/L	3260	5650
Ethylbenzene, ug/L	400	<10
Toluene, ug/L	2240	1200
Trichloroethylene, ug/L	64	11,400
